CONFIDENTIAL INSPECTION REPORT

0000 BELLEAU WOODS, IL 00000

Inspection Date: November 10, 1775

ALLIED HOME INSPECTORS, LLC

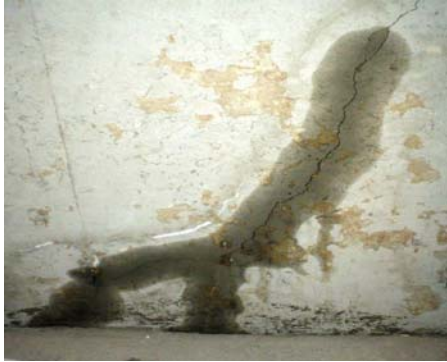
ACTIVE WATER INFILTRATION AT SOUTH FOUNDATION WALL CRACK

STRUCTURE	<ul style="list-style-type: none"> Foundation wall crack at south wall has an active water leak. Suggest professional sealing and repairs to avoid continued water issues.
INTERIOR	<ul style="list-style-type: none"> Master bedroom window lock is defective at west wall. Suggest proper repairs as needed.
PLUMBING	<ul style="list-style-type: none"> Gas leaks detected and tagged on piping adjacent to furnace and water heater. Recommend immediate repair by a qualified contractor or public utility company.
BATHROOM	<ul style="list-style-type: none"> Toilet located in the hallway bathroom is loose at the floor and shows signs of water leaks. Water damage noted at shower floor base and wall. Suggest repairing leak to avoid moisture rot and mildewing.
ELECTRICAL	<ul style="list-style-type: none"> Hazardous double tapped circuit breaker observed in main panel. Recommend repair by a qualified electrician. Exposed high voltage wiring observed at sink disposal, in the attic and basement. Recommend all exposed wiring be properly secured.

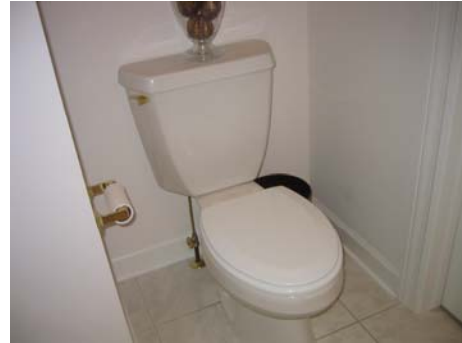
TOILET IN MASTER BATHROOM IS LOOSE AT BASE, SEAL LEAKING

ITEM INSPECTED	DESCRIPTION	REMARKS
Toilets	Appear Serviceable	Toilet in master bathroom is loose at the floor and shows signs of past water leaking. Suggest replacing wax seal and properly sealing toilet to floor.
Sinks	Appear Serviceable	Drain stops operational
Bathtubs	Appear Serviceable	No drain stop present in 2nd floor hall bathroom.
Whirlpool Tub	None	N/A
Showers	Appear Serviceable	Water diverters operational
Ventilation	Appear Serviceable	Improperly vented into attic
GFCI Protection	Appear Serviceable	Suggest monthly testing of all GFCI outlets as a safety precaution.

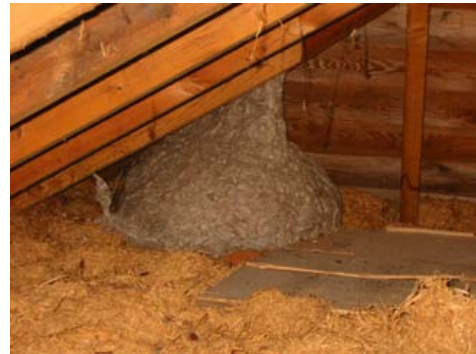
LARGE HORNETS NEST LOCATED IN ATTIC

ATTIC	<ul style="list-style-type: none"> Bathroom exhaust vent is improperly terminated into attic. Recommend properly routing vent to exterior. Large hornets nest in attic, suggest immediate professional extermination..
GARAGE	<ul style="list-style-type: none"> Safety reverse not functional at garage door operator. Recommend service or replacement as a safety precaution.
ROOFING	<ul style="list-style-type: none"> Roof covering shows signs of shingle damage at rear of property. Suggest professional repairs by a qualified roofing contractor
<p>*** ALL REPAIRS SHOULD BE COMPLETED BY A QUALIFIED PROFESSIONAL CONTRACTOR ***</p> <p><i>Please see full comments noted on detailed pages and rear notes.</i></p>

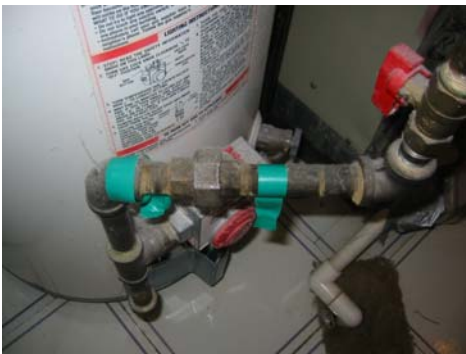
GAS LEAKS DETECTED AT UNION ON SUPPLY LINE SERVICING WATER WATER

- Gas leaks detected and tagged on piping adjacent to furnace and water heater. Recommend repair by a qualified contractor or public utility company.

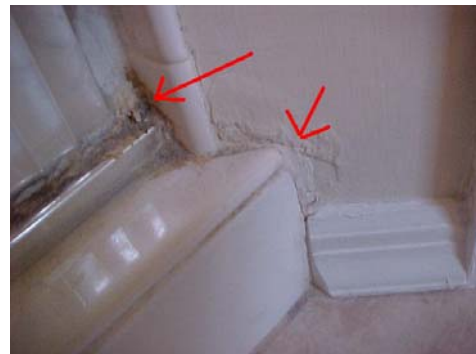
WATER LEAK AND WALL DAMAGE AT HALLWAY BATHROOM SHOWER BASE

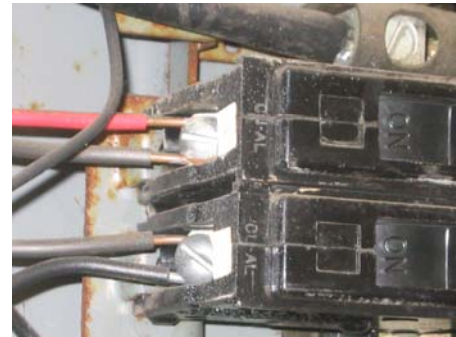
**HAZARDOUS DOUBLE TAP CIRCUIT
WIRING AT MAIN PANEL.**

- **Double tapped circuit breaker observed in main panel. Recommend repair by a qualified electrician.**
- **Exposed wiring observed in attic and basement. Recommend all exposed wiring be properly concealed.**

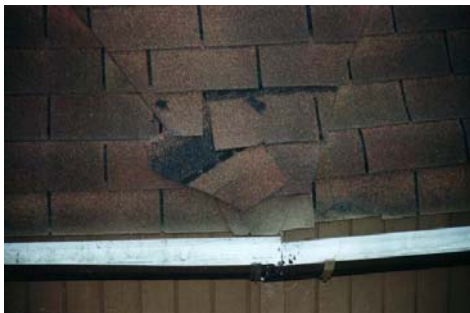
**ROOF SHINGLES DAMAGED AT
GARAGE REAR ELEVATION**

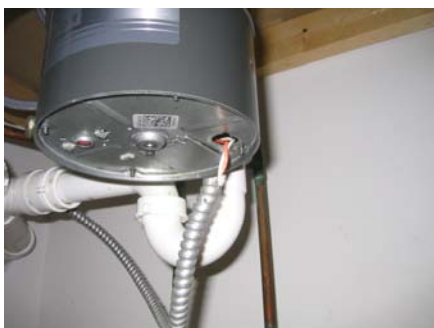
**EXPOSED HIGH VOLTAGE AT
SINK DISPOSAL**

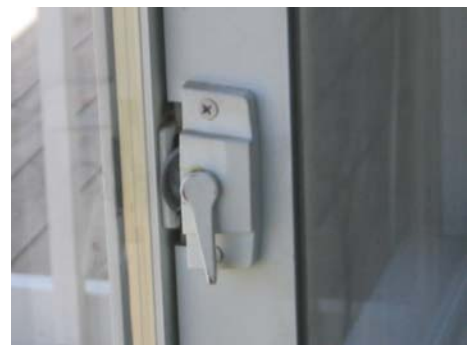
**WINDOW LOCK DEFECTIVE AT
MASTER BEDROOM WEST WALL**
